## GEOFABRICS CASE STUDY

# GEOGRID REINFORCEMENT SECURES COASTAL HIGHWAY SLOPE AT KATIKI BEACH

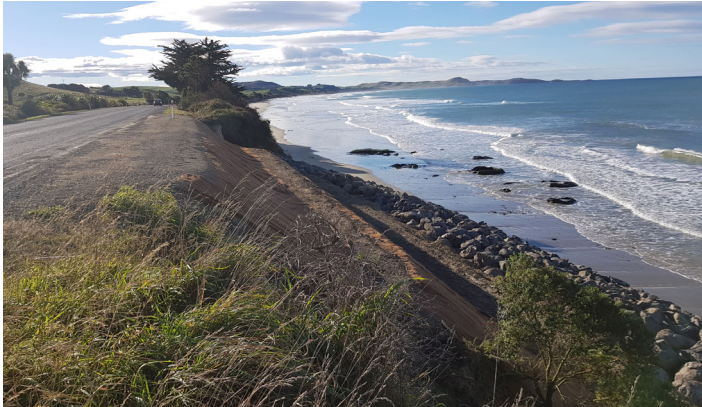
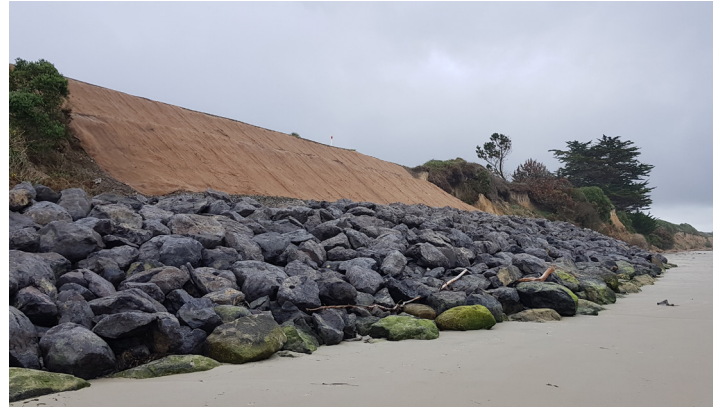
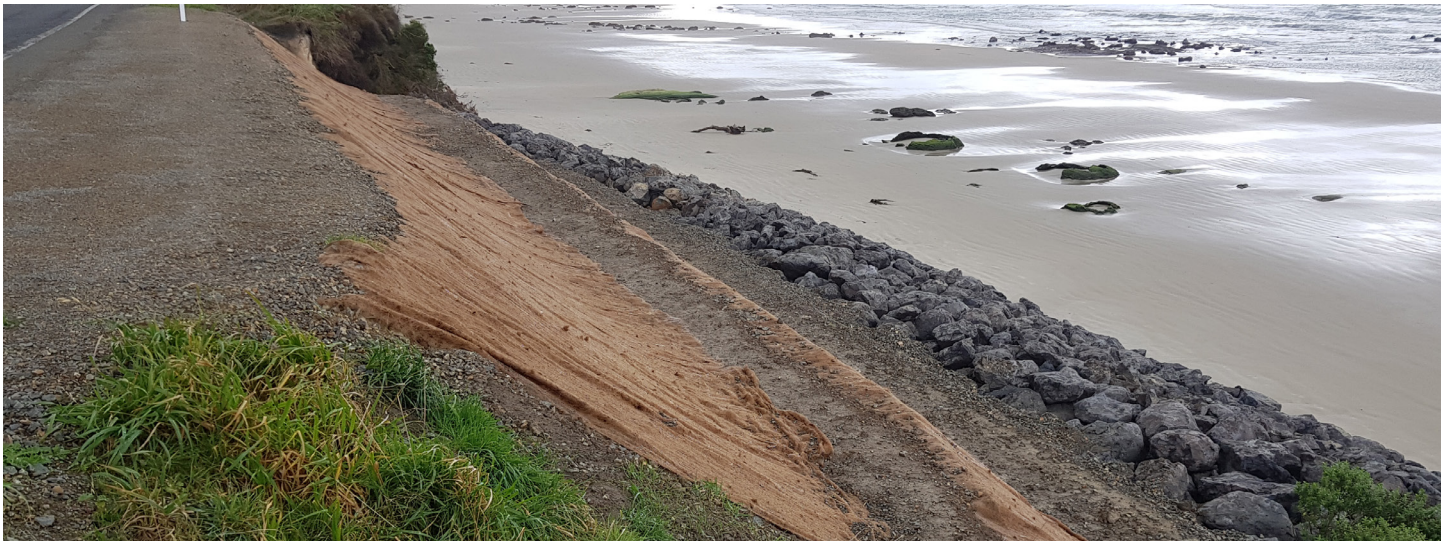
Slope reinforced for  
**heavy  
traffic**

**Erosion  
controlled**  
with geogrid reinforcement

The approved solution involved constructing a nine-metre-high Miragrid GX100 geogrid-reinforced embankment to reinstate the eroded slope. Additional protection included a two-metre-thick layer of armour rock at the slope toe, extending one metre below the lowest historic beach level. Bidim® Green A64 non-woven geotextile was placed beneath the reinforced fill, and an erosion control mat was installed on the surface to encourage revegetation, with rip-rap at the toe for extra stability. The road shoulder was reinstated to a minimum width of three metres to allow future bicycle access, with a rope barrier installed on properly supported ground.
