GEOFABRICS CASE STUDY

GABION BASKETS SECURES MAJOR HIGHWAY AFTER CYCLONE AND HEAVY RAINFALL

PROJECT DESCRIPTION

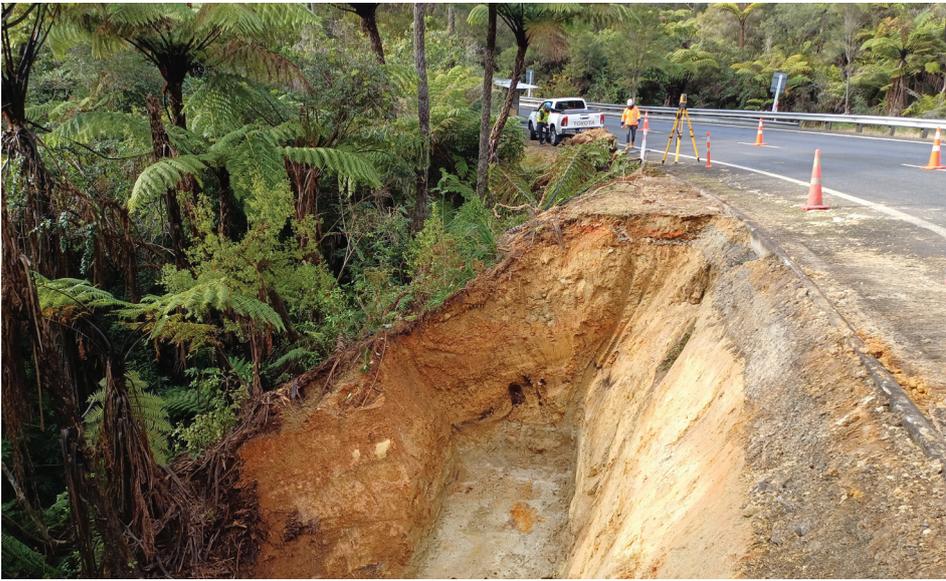
44
gabion
baskets
installed

Completed within
two
weeks

A total of 44 gabion baskets were installed by the contractor in accordance with Geofabrics' installation instructions. The baskets were lined with Bidim Green A39 non-woven geotextile, covering 750 m², which provided separation between the soil and the gabion baskets. This facilitated drainage and prevented erosion, ensuring the long-term stability and performance of the structure.
