GEOFABRICS CASE STUDY

FLOODWAY EROSION CONTROL IN DEFENCE WITH CONCRETE CANVAS

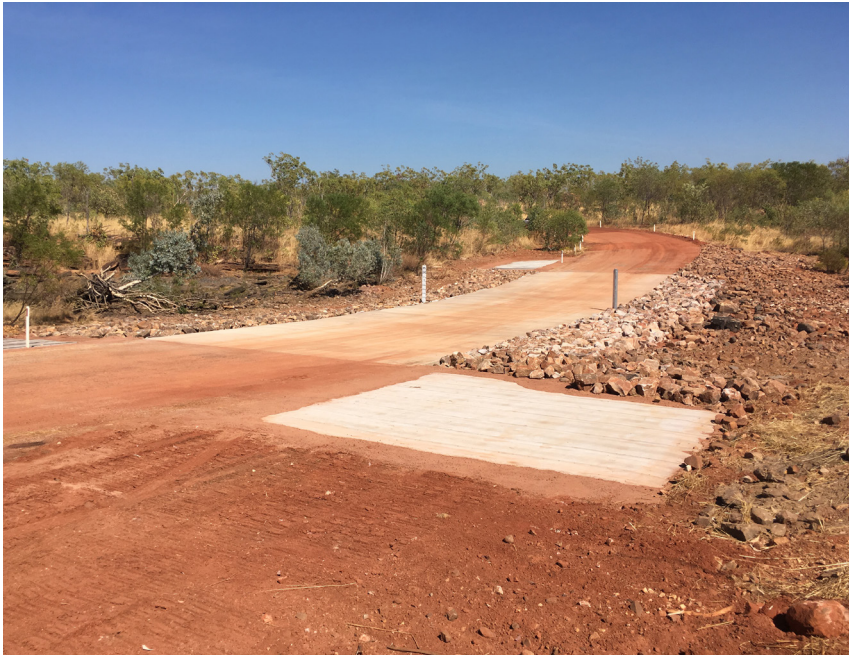
**9,100m²
Concrete
Canvas**
installed

A total of 9100m² Concrete Canvas was installed on both the upstream and downstream side of the floodways. The local contractor was professional and meticulous in following the design methodology provided by Concrete Canvas ensuring the leading edges were attached to the concrete pavement using stainless steel flatbar that were fixed to the concrete. The trailing edges and the end of the floodway terminations were buried and grouted into place.
