## GEOFABRICS CASE STUDY

# CONCRETE CANVAS PROTECTS THE ARMIDALE STATION FROM EROSION

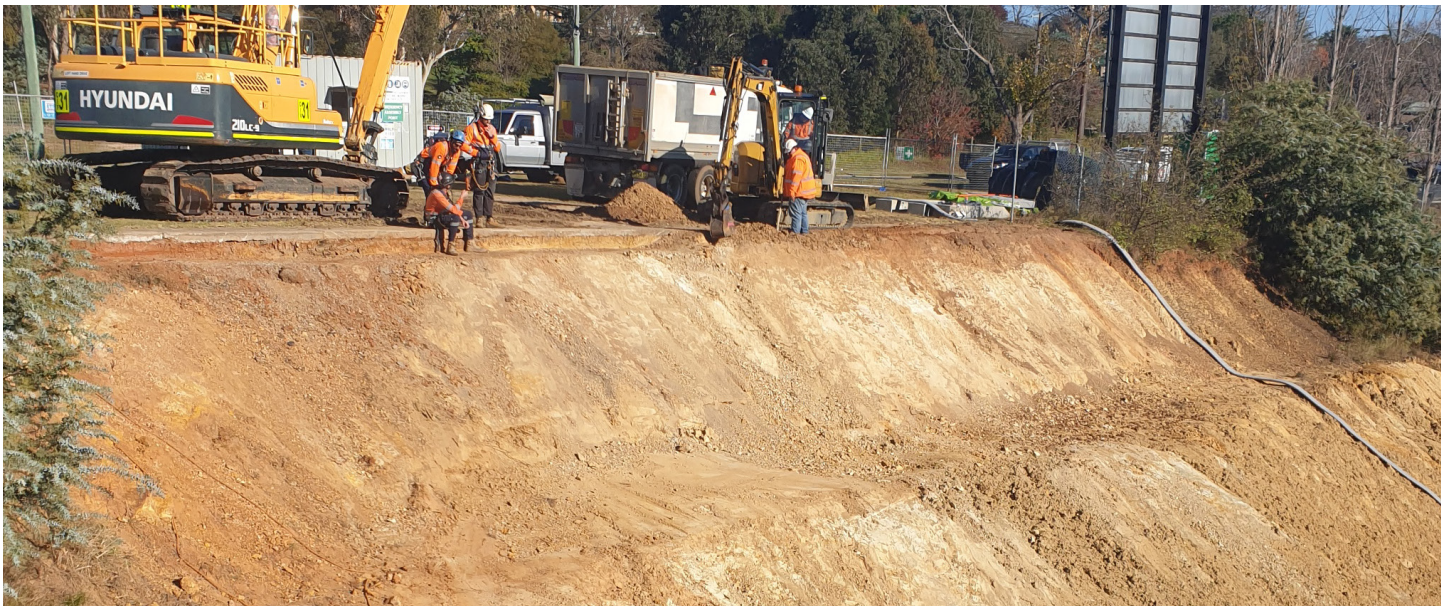
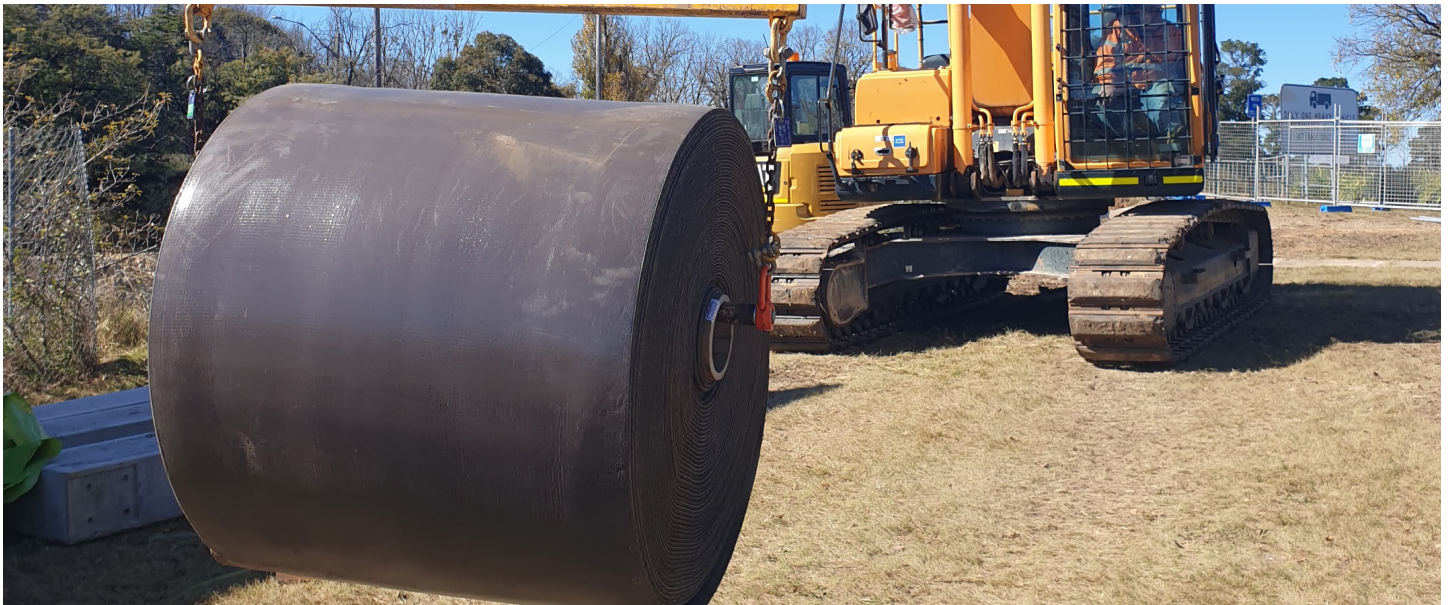
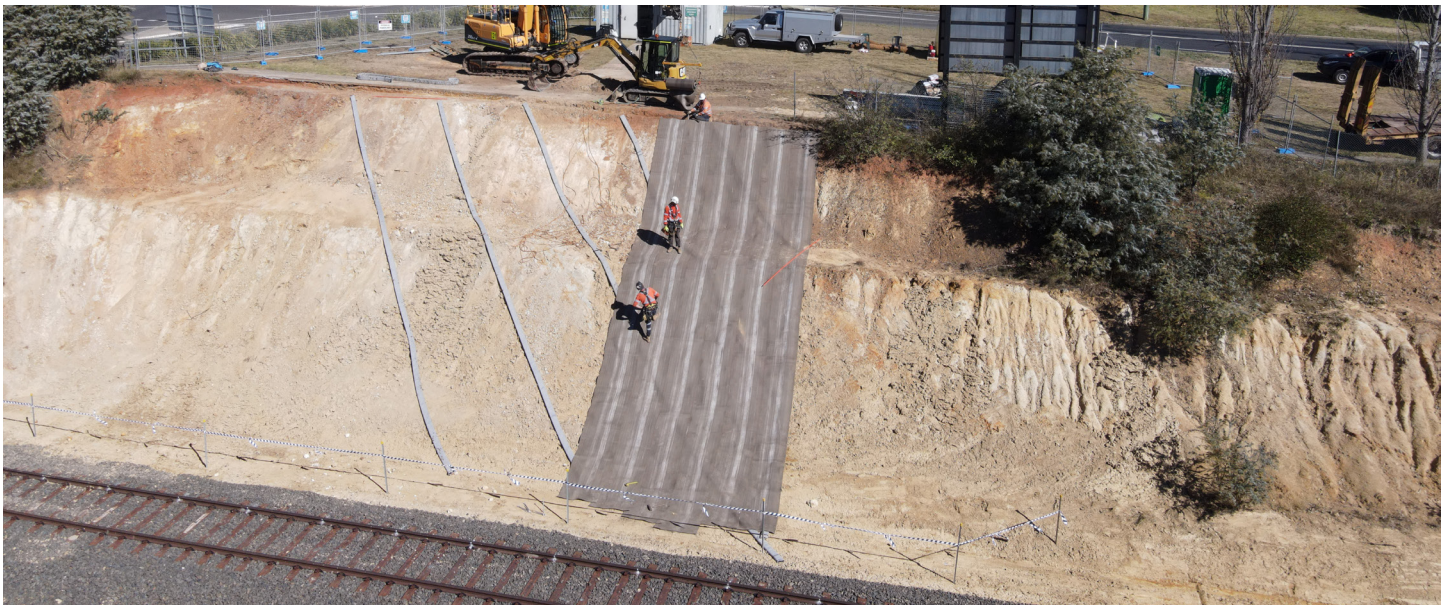
The project commenced by trimming the face of the slope and removing some vegetation so that the installation could begin with a clean slate. Stainless steel screws were fitted every 100mm along the overlaps of Concrete Canvas GCCM where adhesive had also been applied. Slope pins were installed at every three-metre centre along the edges to safely secure the Concrete Canvas GCCM to the slope. A water truck was then used to hydrate the Concrete Canvas GCCM - the entire installation took only four days.
